# Olcott Memorial School, Besant Nagar, Chennai, TN – Site Visit Report by Anjana Mohan

Anjana Mohan - Asha Site Visit - 27 February 2011

## Water Project Review

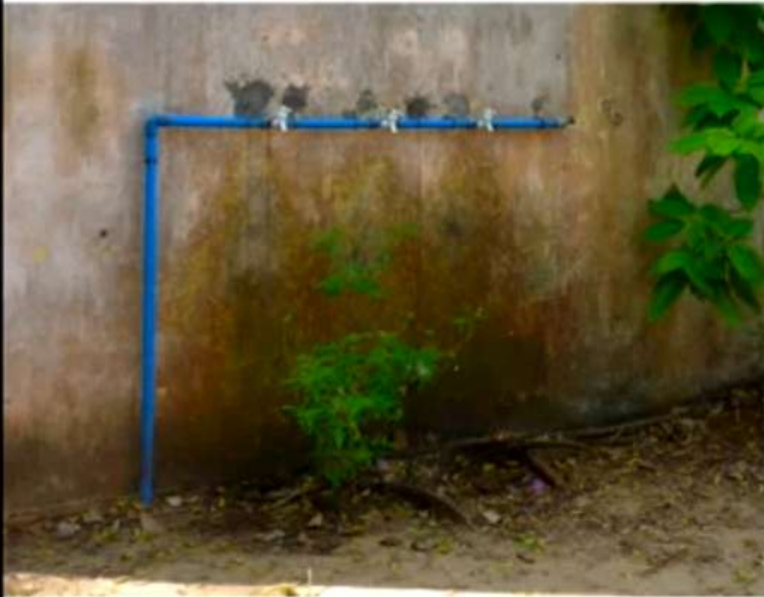
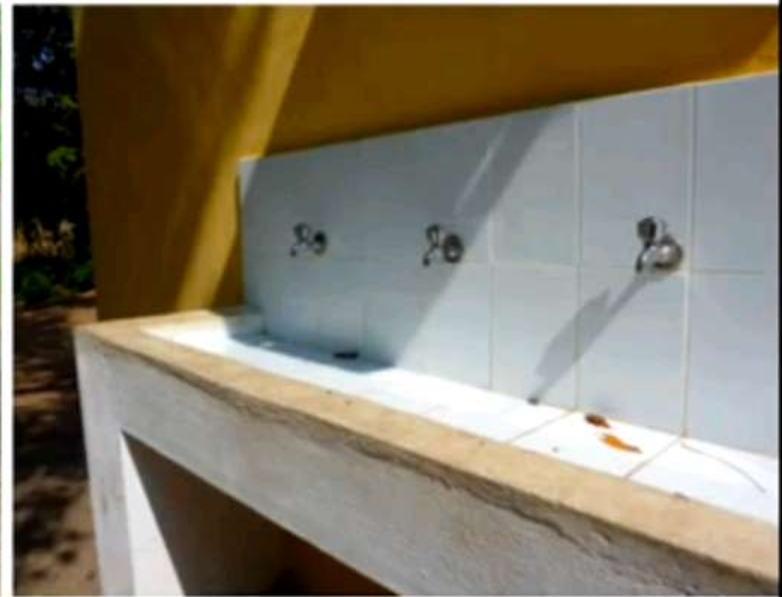
[LEFT - BEFORE PICTURE]: Fewer taps, mounted high, children (typically without shoes) would struggle to wash, there was a lot of wastage of water as a result of the inefficient access, and splashing water made a mess.  
[RIGHT - AFTER PICTURE]: New taps are easy for children to access, foster a sense of hygiene & reduce waste.

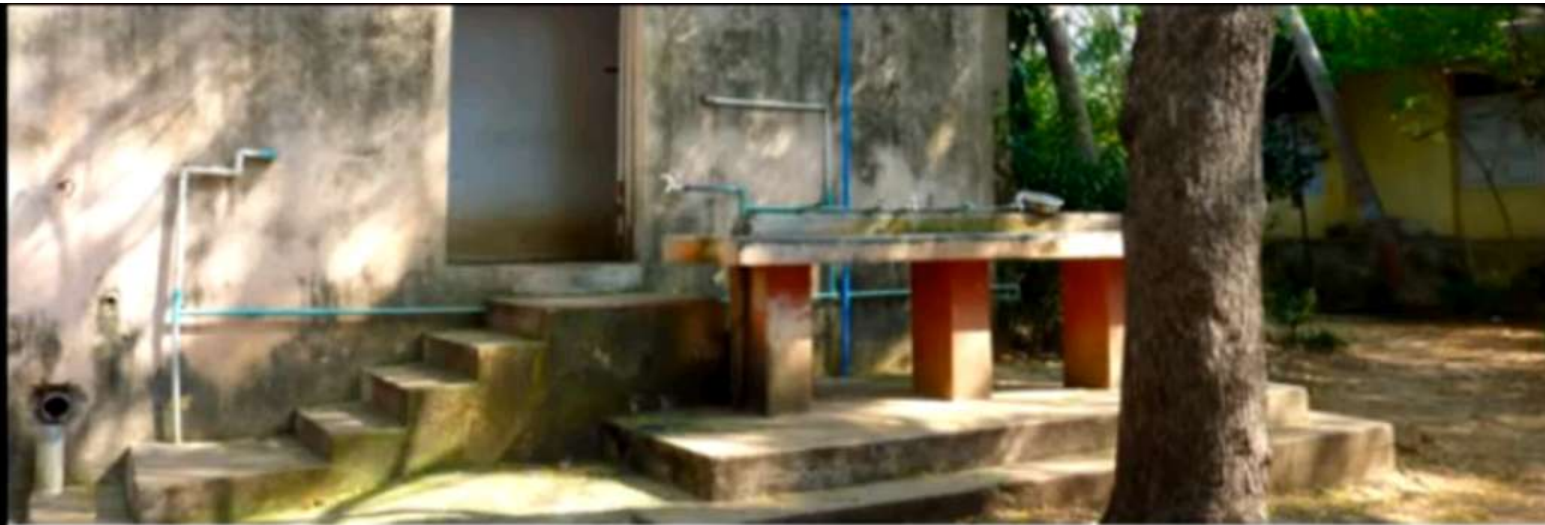
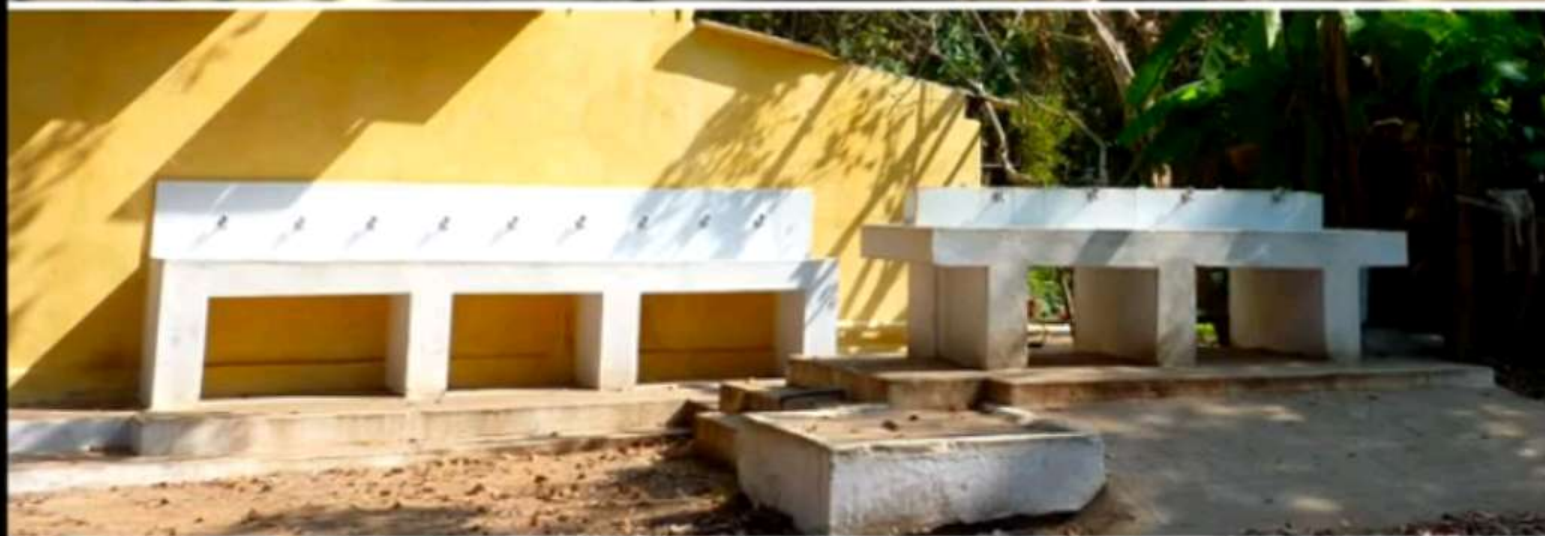
[ UPPER - BEFORE]: Fewer taps to drink from, aging pipes and slow water flow, leaks.

[LOWER - AFTER PICTURE]: Washing taps in the background and drinking water island in the foreground. Both foster a sense of hygiene and invites children to keep the area clean. More taps allow more children to wash and drink with less of a mess. Concrete around these areas keeps the children's bare feet clean.

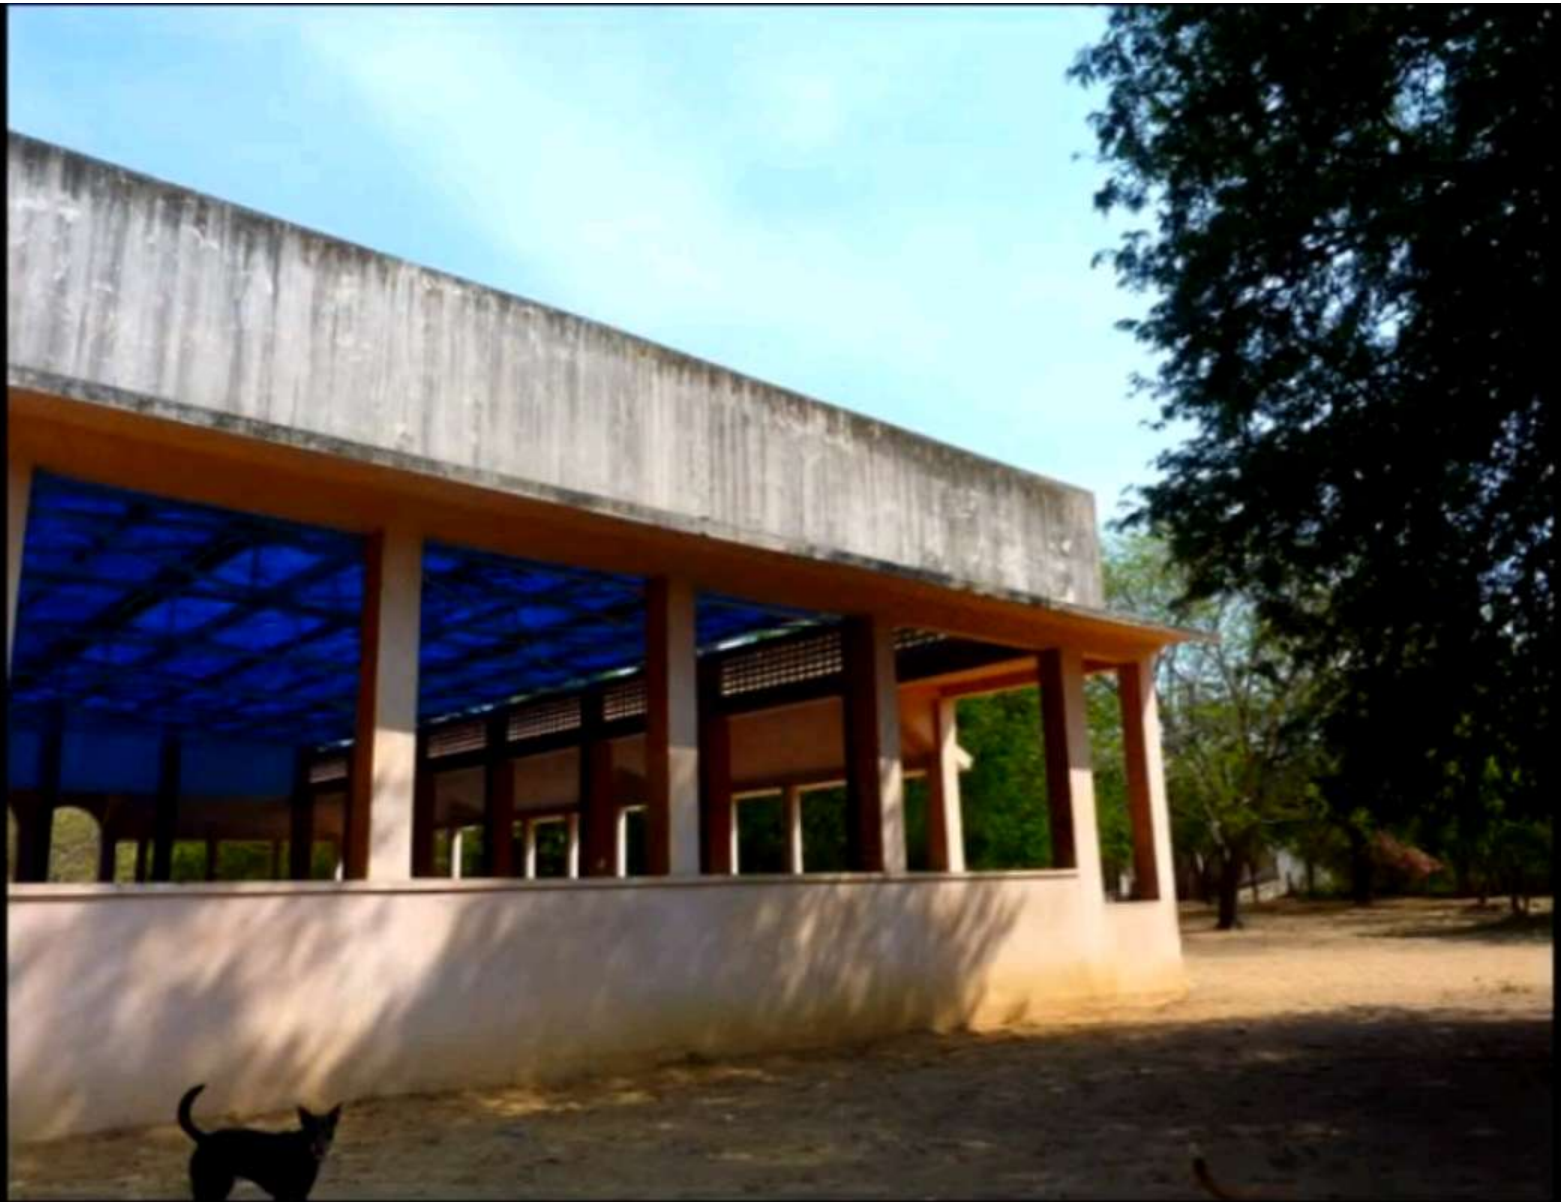
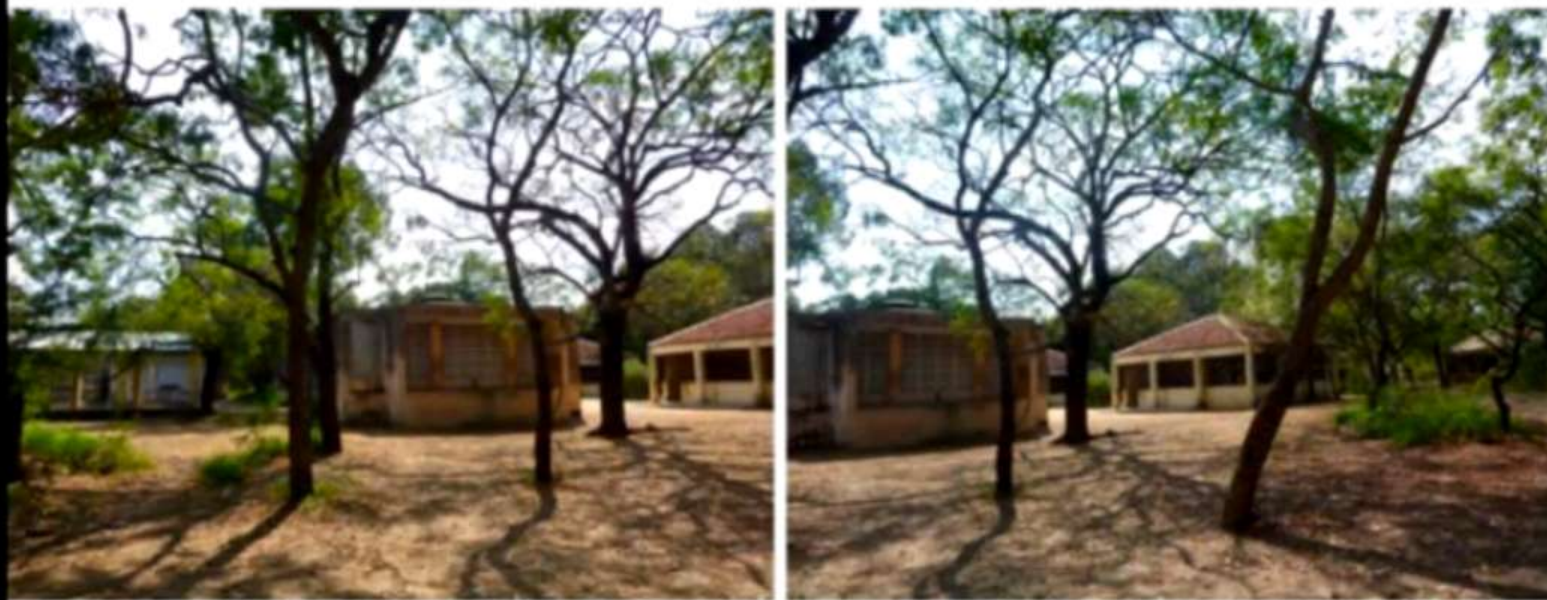
[ABOVE - CLASSROOMS]: The general feed of the school is like an open air courtyard with separate classrooms strewn around.

[LEFT - ASSEMBLY HALL]: Note the fiberglass roof covering the hall.

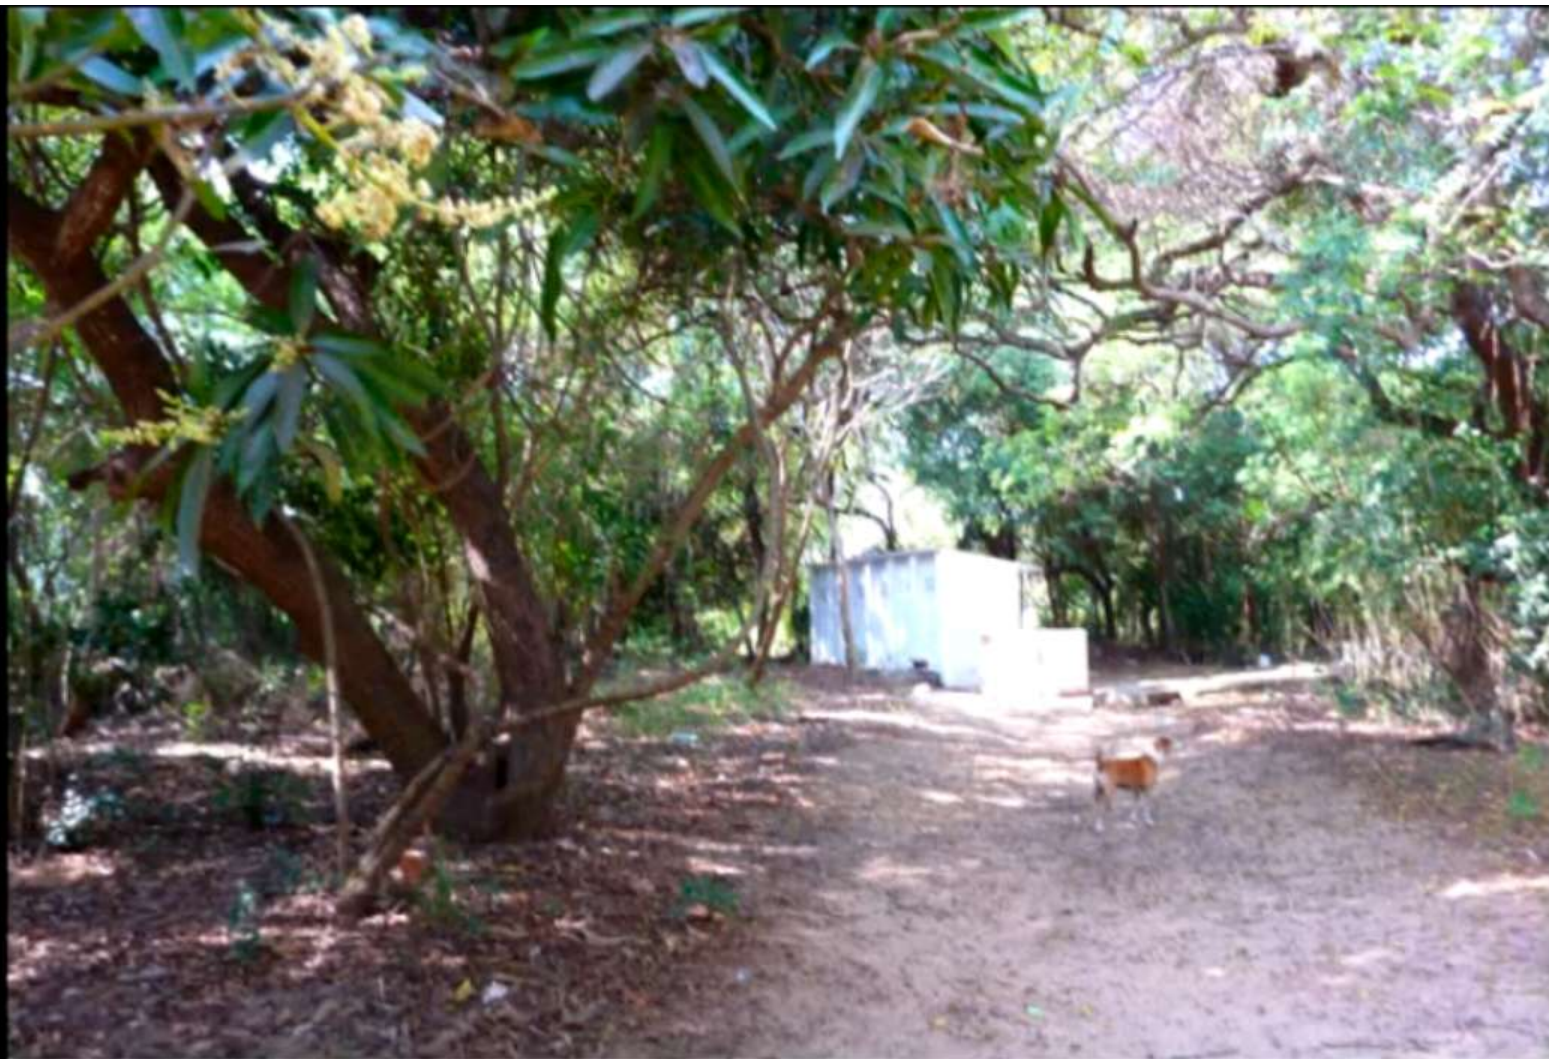
[PRIMARY SCHOOL GIRLS TOILET] It's a long trek from the classroom to the bathrooms. This is the path about halfway between the classroom and the Primary School toilets.

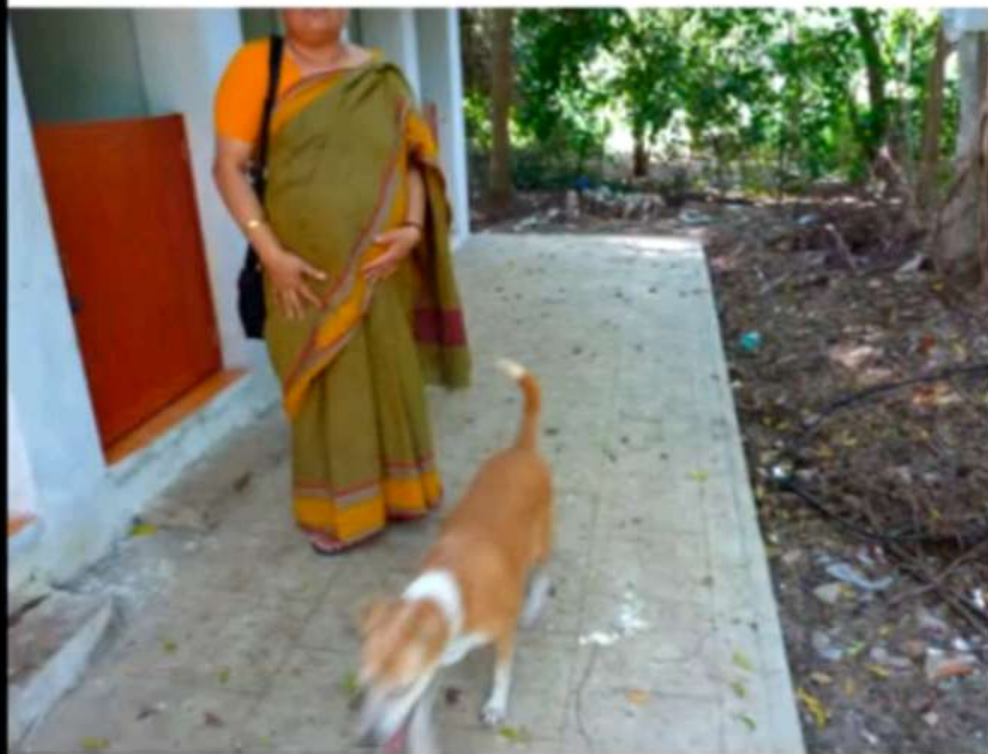
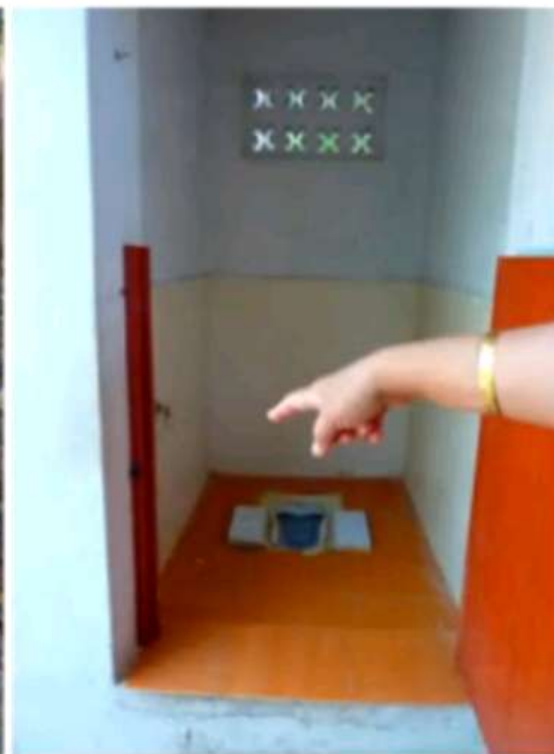
[LEFT - AREA OUTSIDE OF TOILETS]: Little children had to previously lug their buckets of water along this path (spilling and making a mess), and then use muddy toilets. It was hard to keep clean and used too much water.  
[RIGHT - TILED TOILETS]: The concrete stoop and tiles facilitate hygiene training & reduce water use for cleaning.

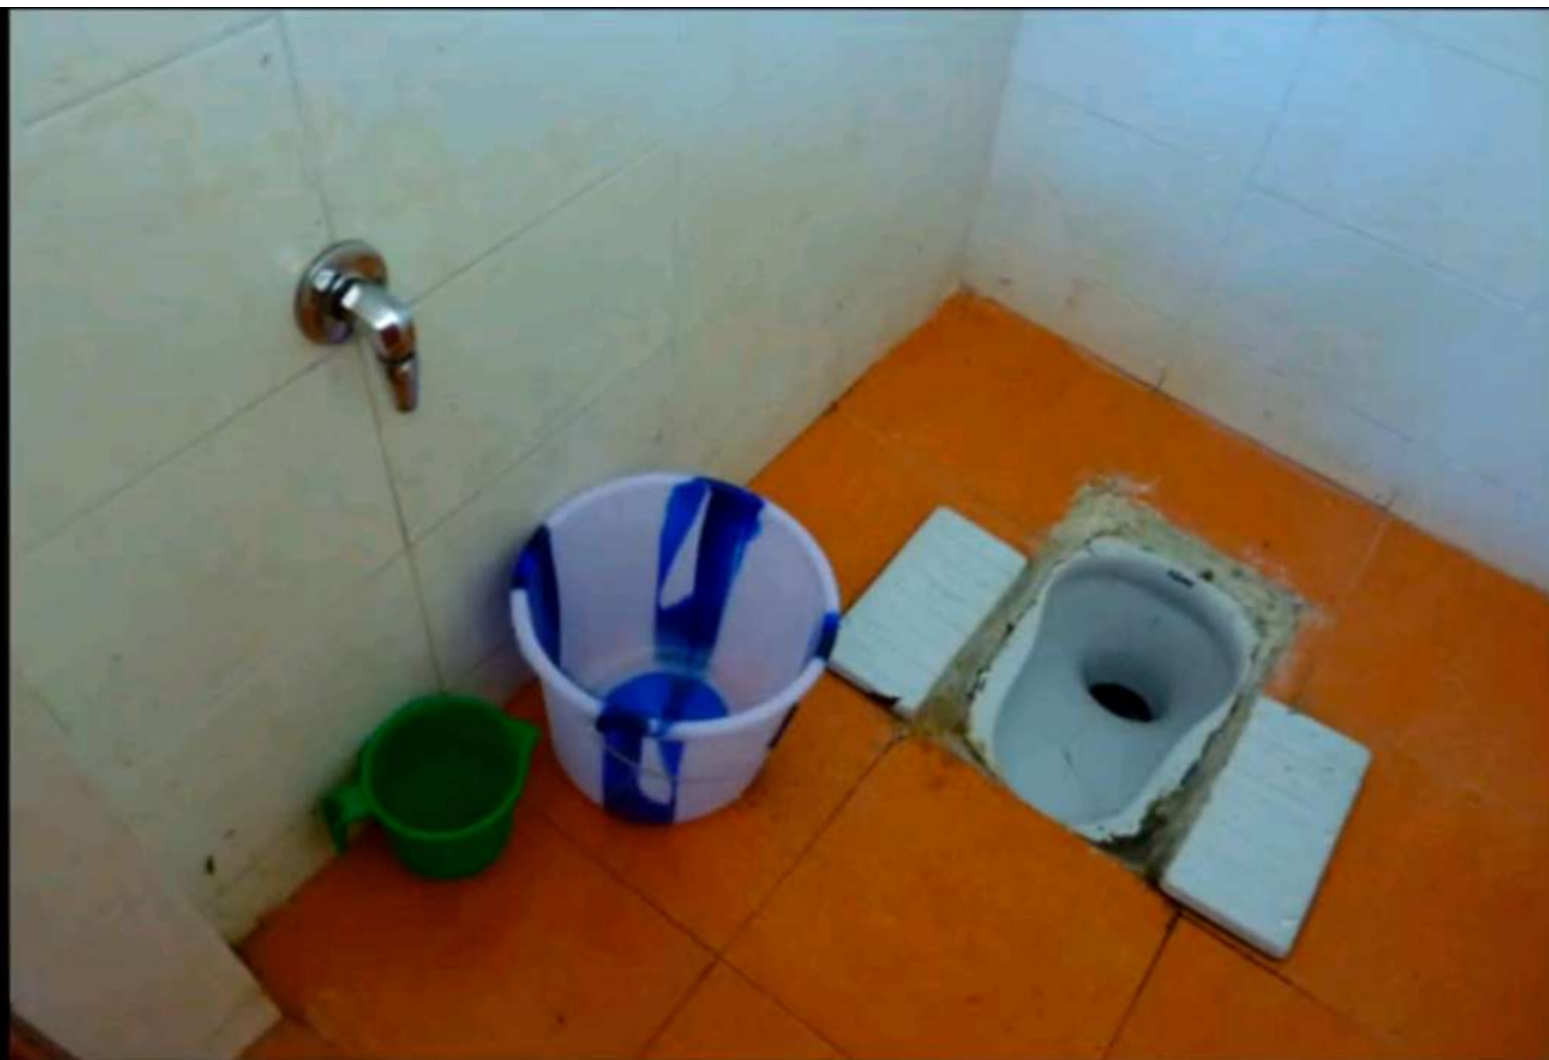
New piping has been installed between the tank outside the toilets, so that there is running water into every toilet. This allows the little ones to not have to carry water in, spilling and making a mess. It also makes it much easier to clean the toilets. Since there is only one pipe for all toilets, at full capacity, the water pressure is weak.

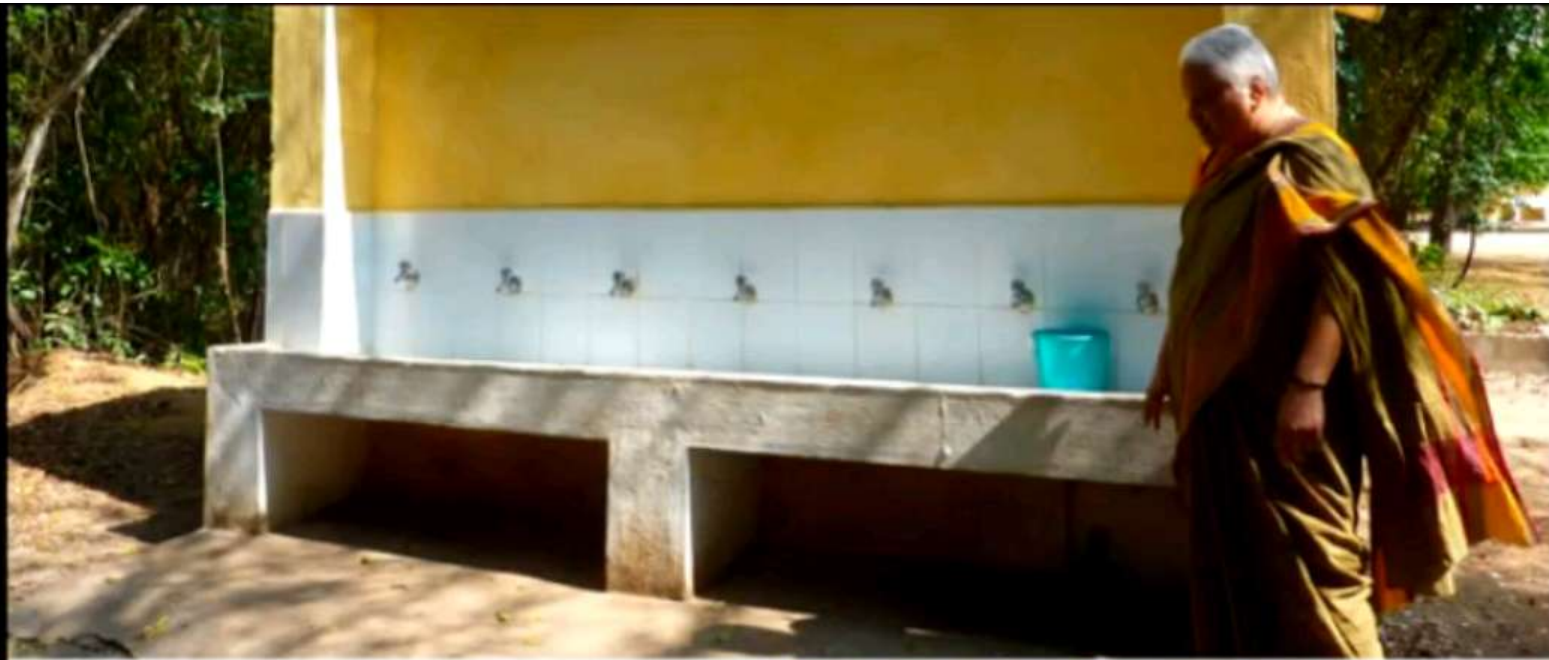
[ABOVE - TAPS AT THE STAFF ROOM]: This is the new washing area for the Primary School children. More taps have been given for the greater volume of children who all use this area for washing their bowls / plates.  
[LEFT - STAFF ROOM] . [RIGHT - LOOKING BACK TOWARDS THE WATER TANK]

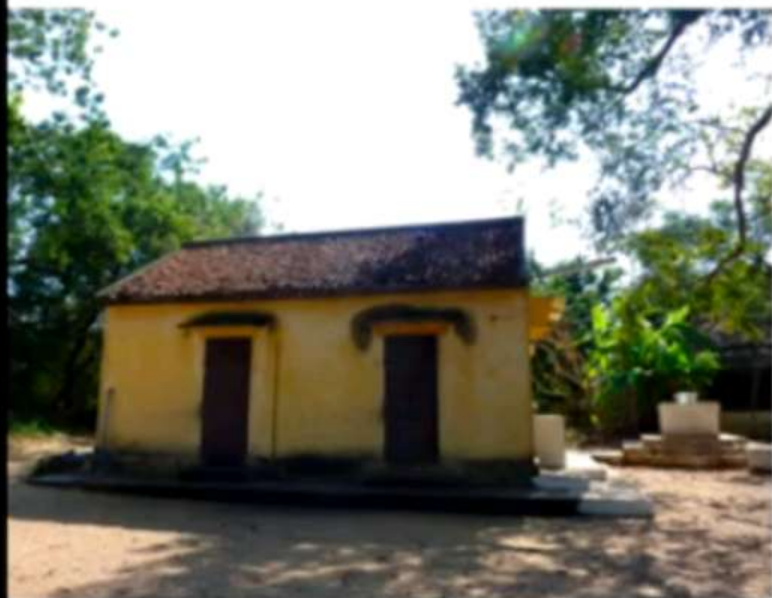
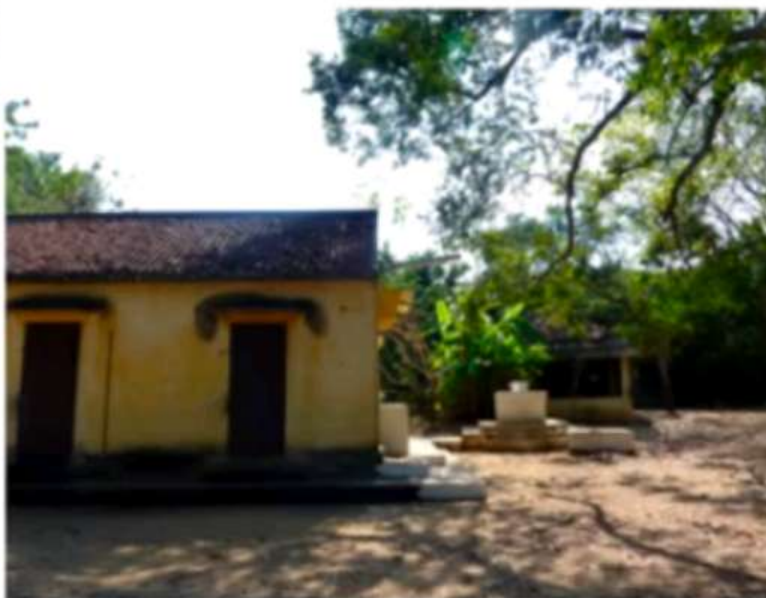
[ABOVE - KITCHEN]: The kitchen is just past the watertank. Notice the new washing water taps along the right wall of the building, as well as the drinking water taps on the island to the right of it.

[LEFT - NEW TAPS]: Fostering pride, cleanliness and facilitating slum children to take these sentiments home.

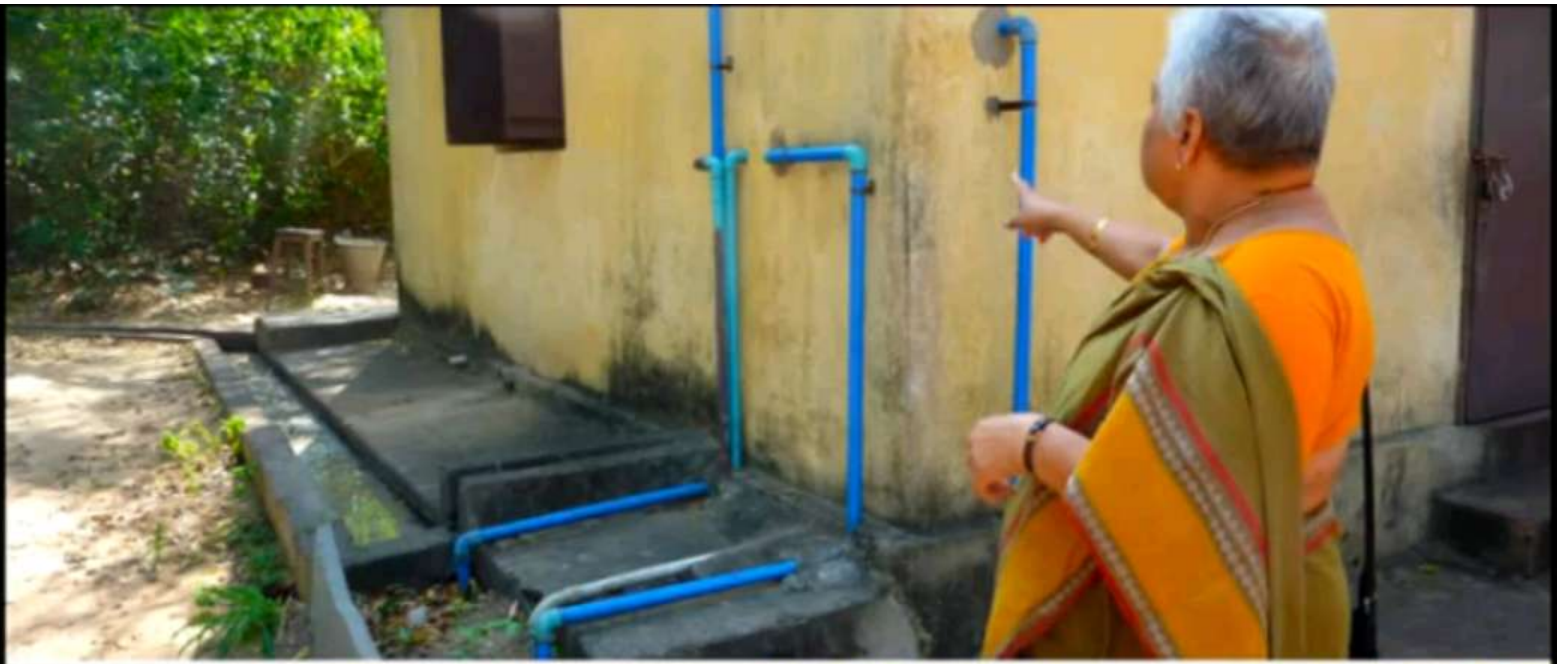
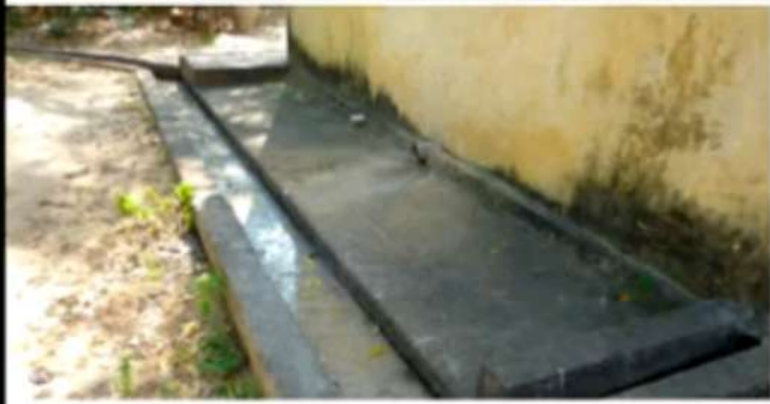
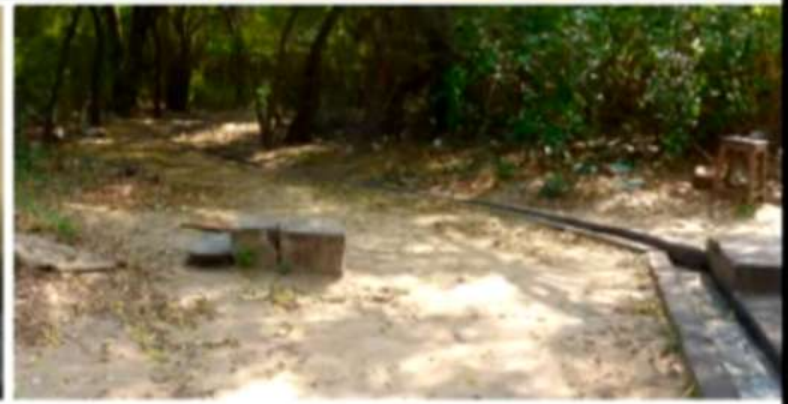
Kitchen waste is allowed to drain into the woods.

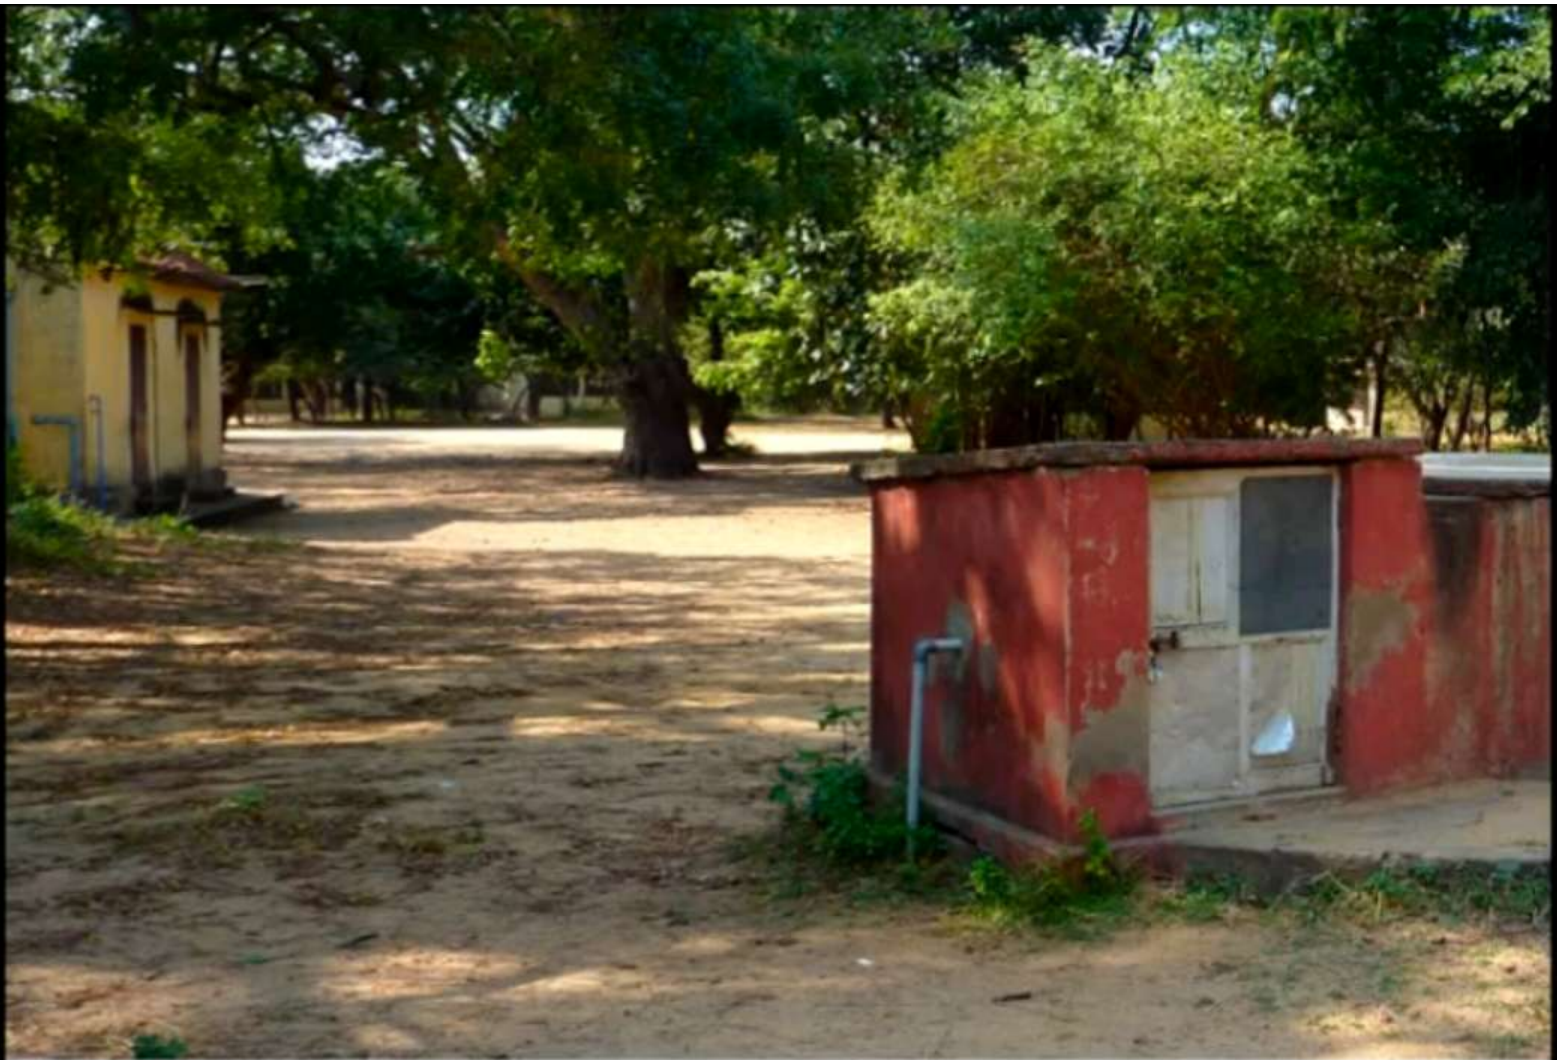
Moving further beyond the kitchen and past the pump. (Kitchen on the left of the image above).

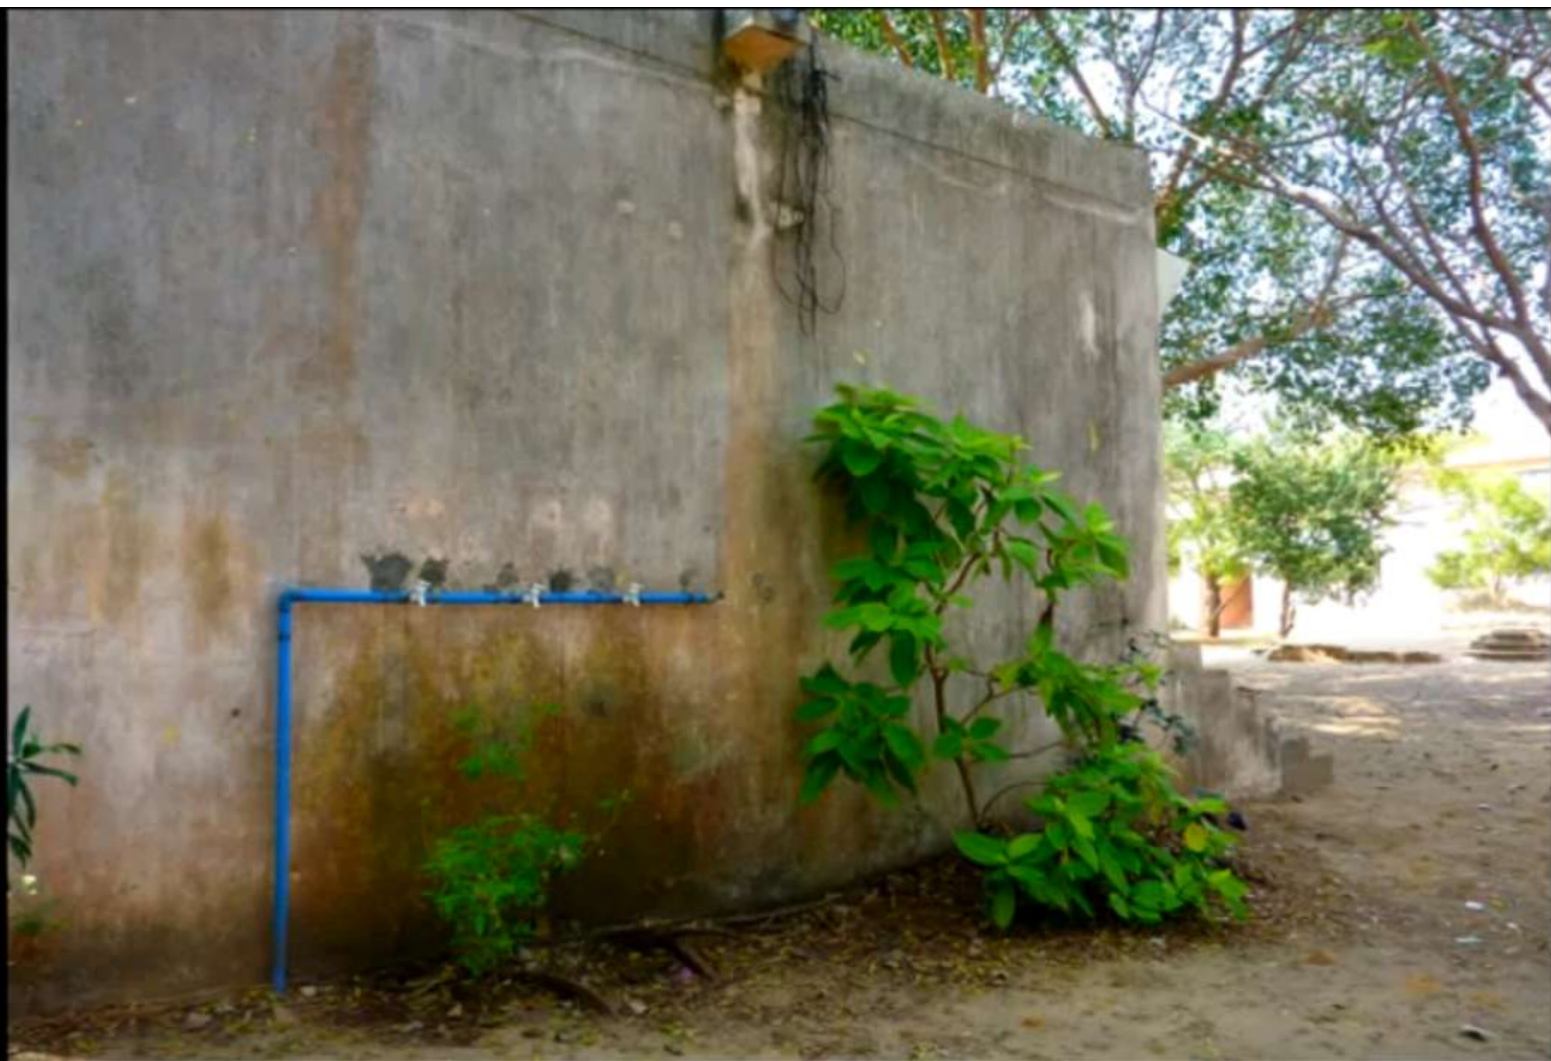
[OLD STYLE TAPS]: Inadequate number of taps are also mounted unproductively high. Children make a mess while washing their bowls, and have dirty legs from the spatter of food and water. More water is wasted in clean-up.

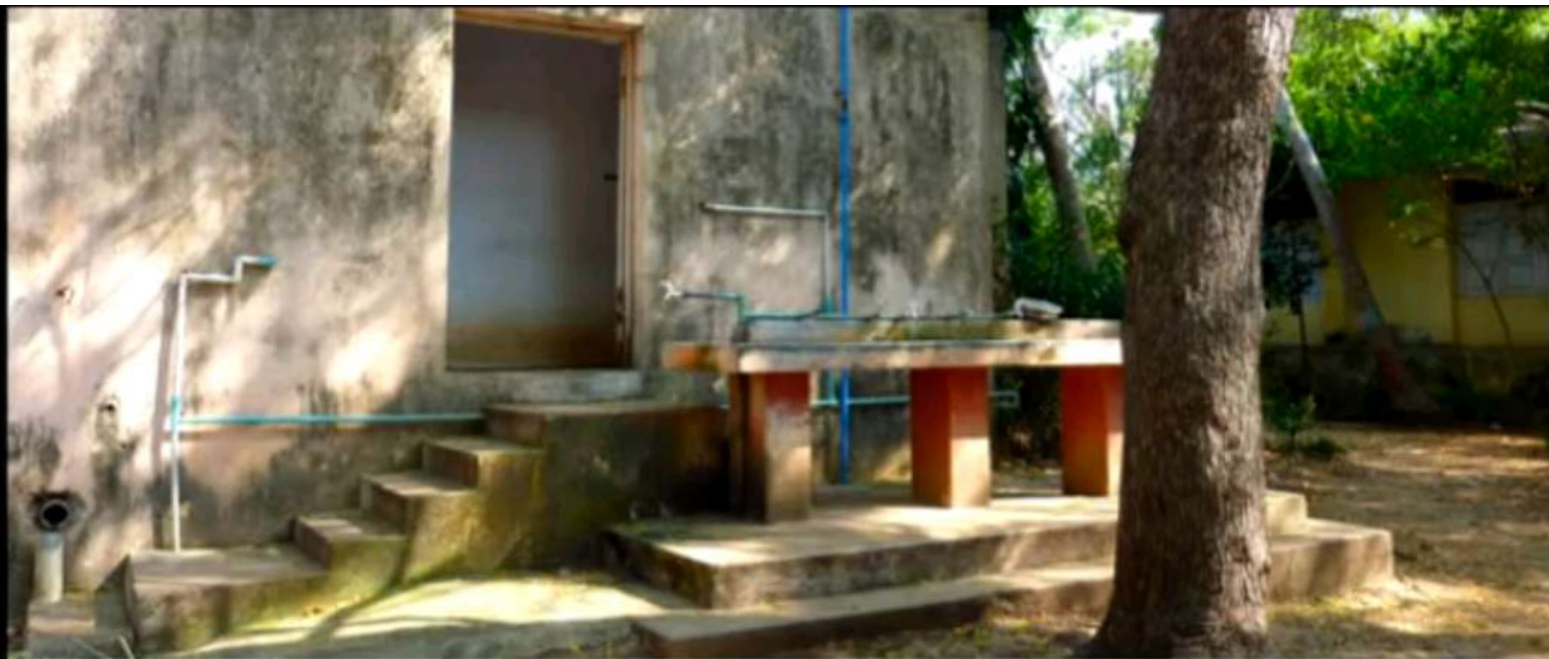
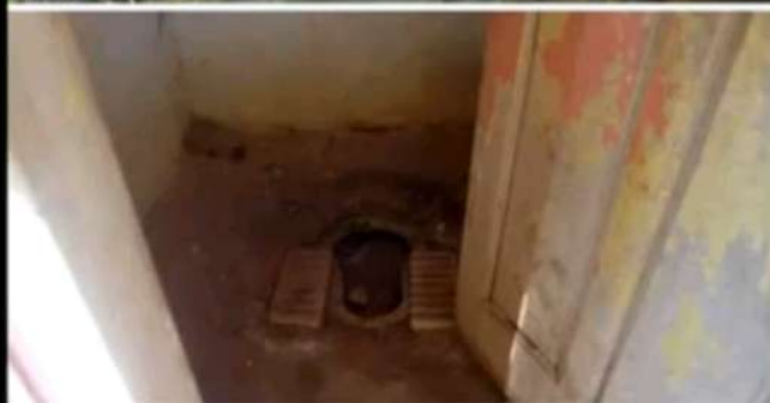
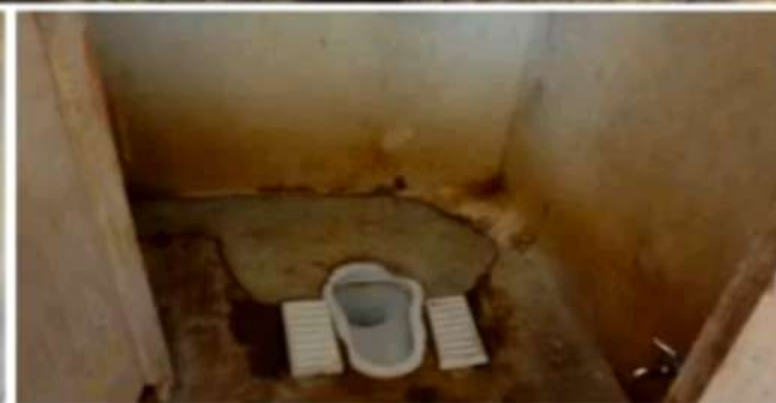
[STAFF TOILETS]: In front of the staff toilets is the old-style of drinking water island. Inadequate taps and old pipes. Difficulty in obtaining water to clean the staff toilets have led to only one being used.

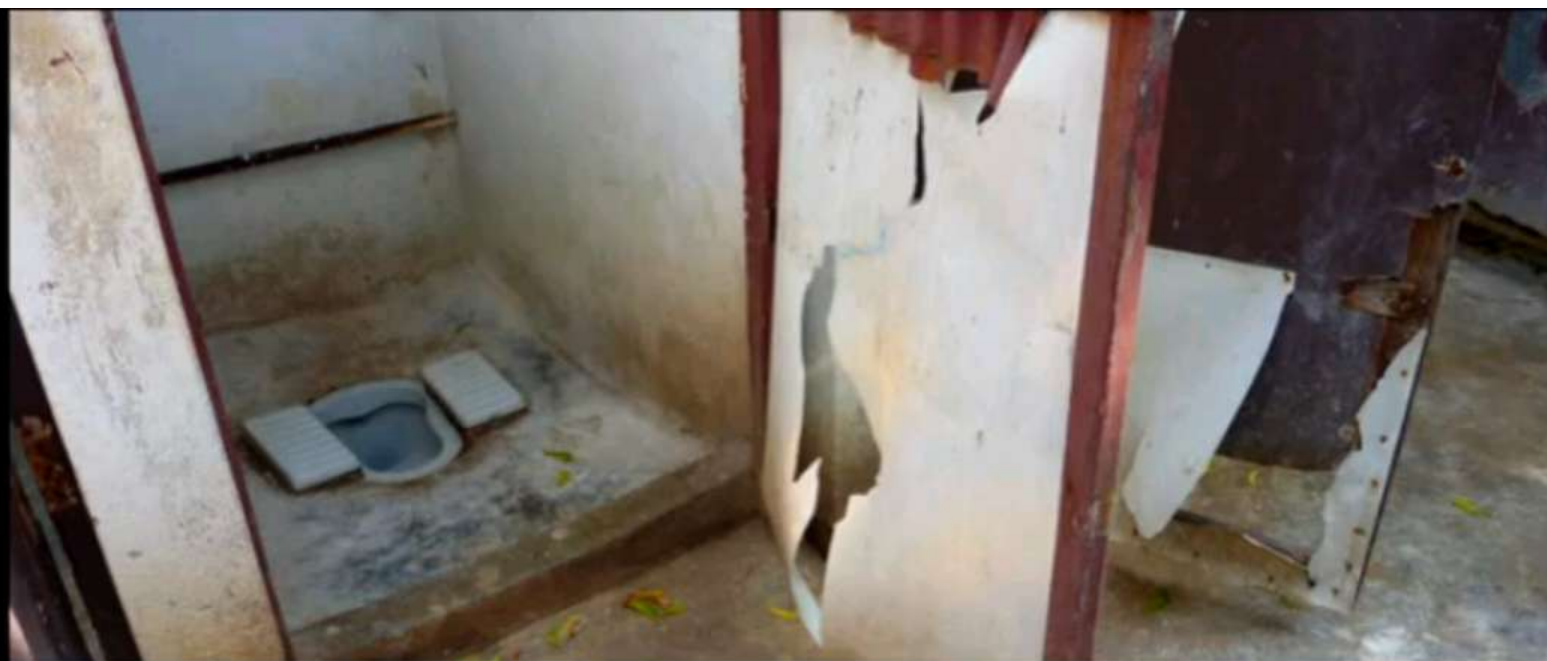
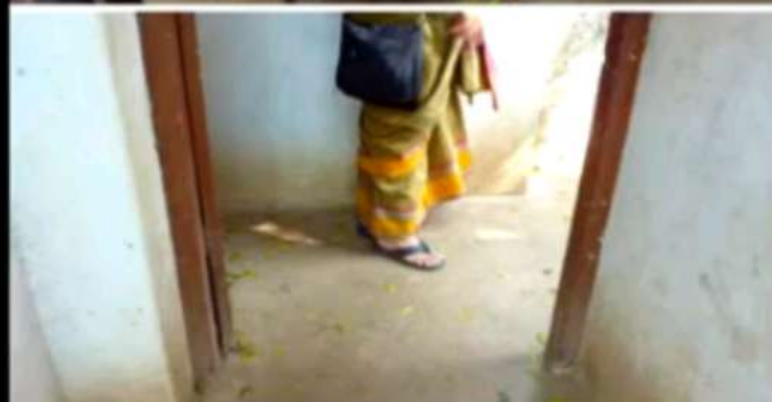
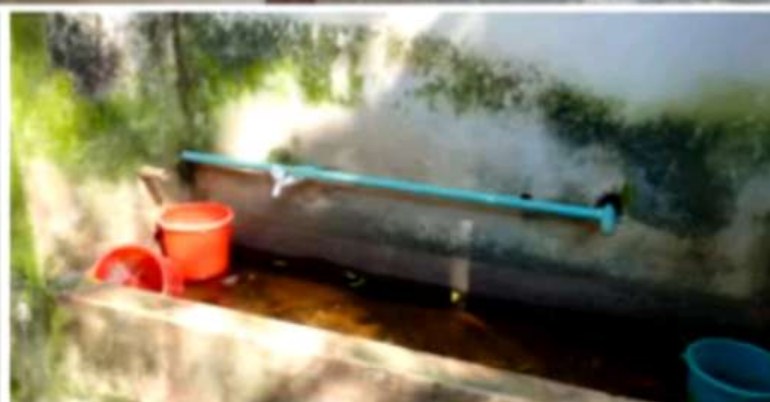
[BOYS TOILET]: Pans have been replaced, but tiling is vastly preferable. Commodes are covered, but the area in front is open to above. Doors are old and worn out. Some pipes were replaced many years ago out of necessity. Note that both boys and girls have to carry buckets of water from the outside into the stalls, which is messy.

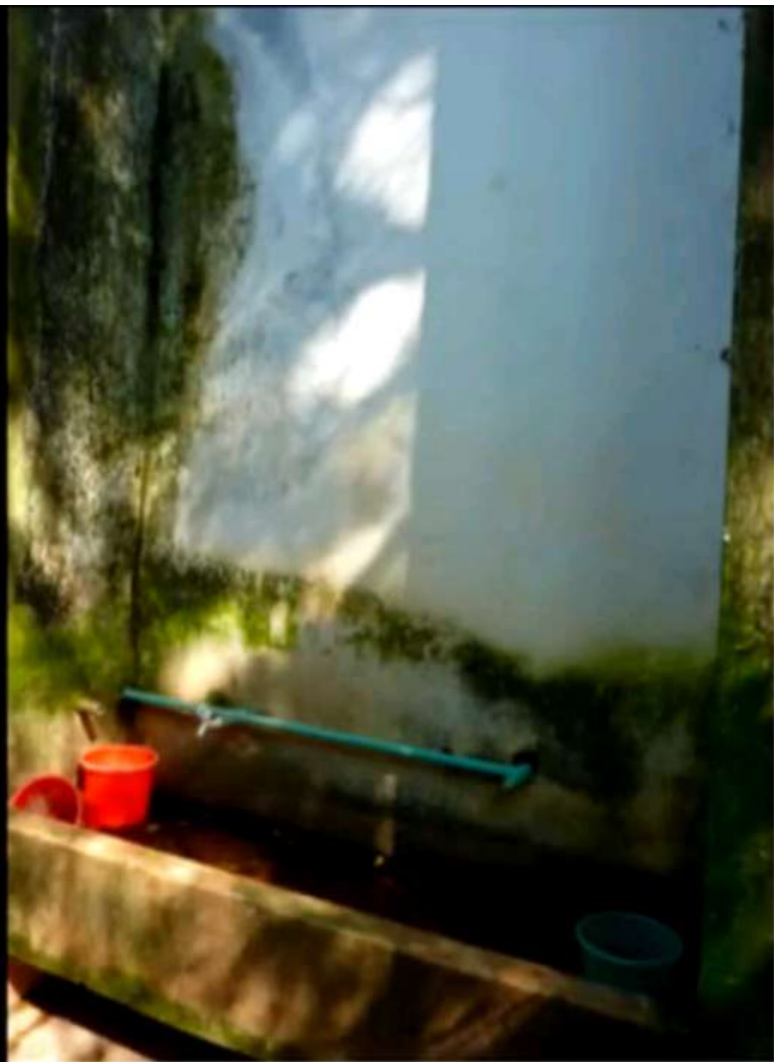
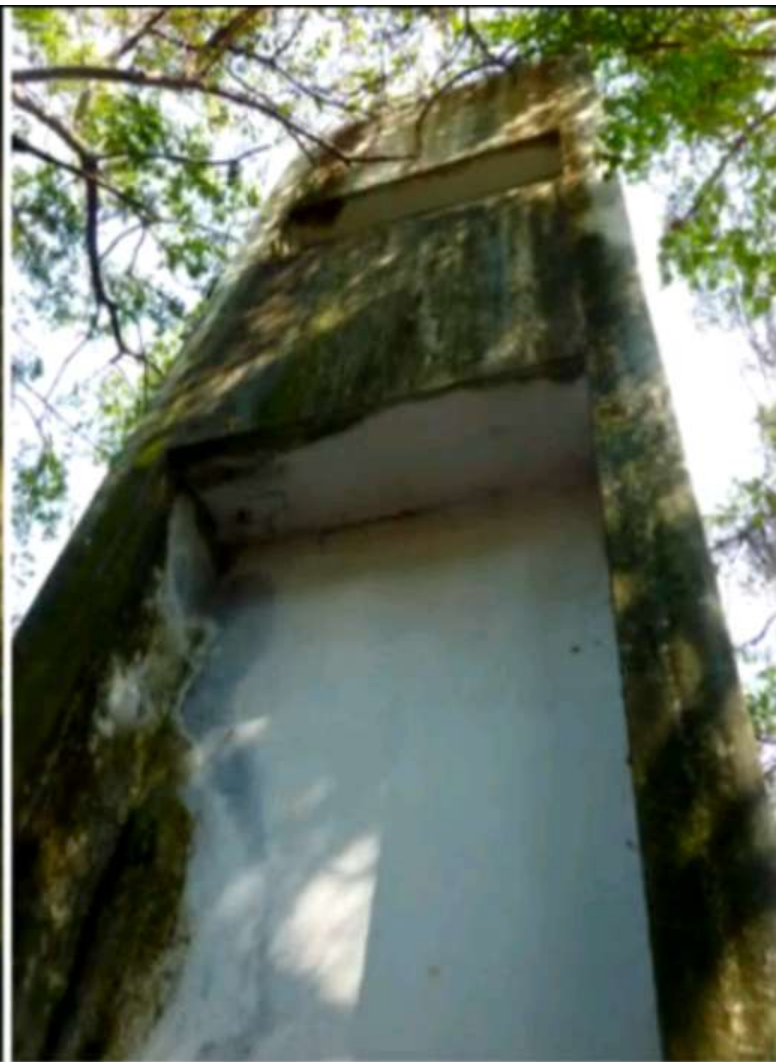
[GIRLS TOILET SINK]: Sink is connected to a pressure tank above. Ms. Suryanarayanan would like to cover this outside area with a fiberglass cover (Recall picture of the Hall), so that going to the toilet when it is raining is easier and less messy.
