# Olcott Memorial School, Besant Nagar, Chennai, TN – Site Visit Report by Anjana Mohan

Anjana Mohan - Asha Site Visit - 27 February 2011

## Water Project Review

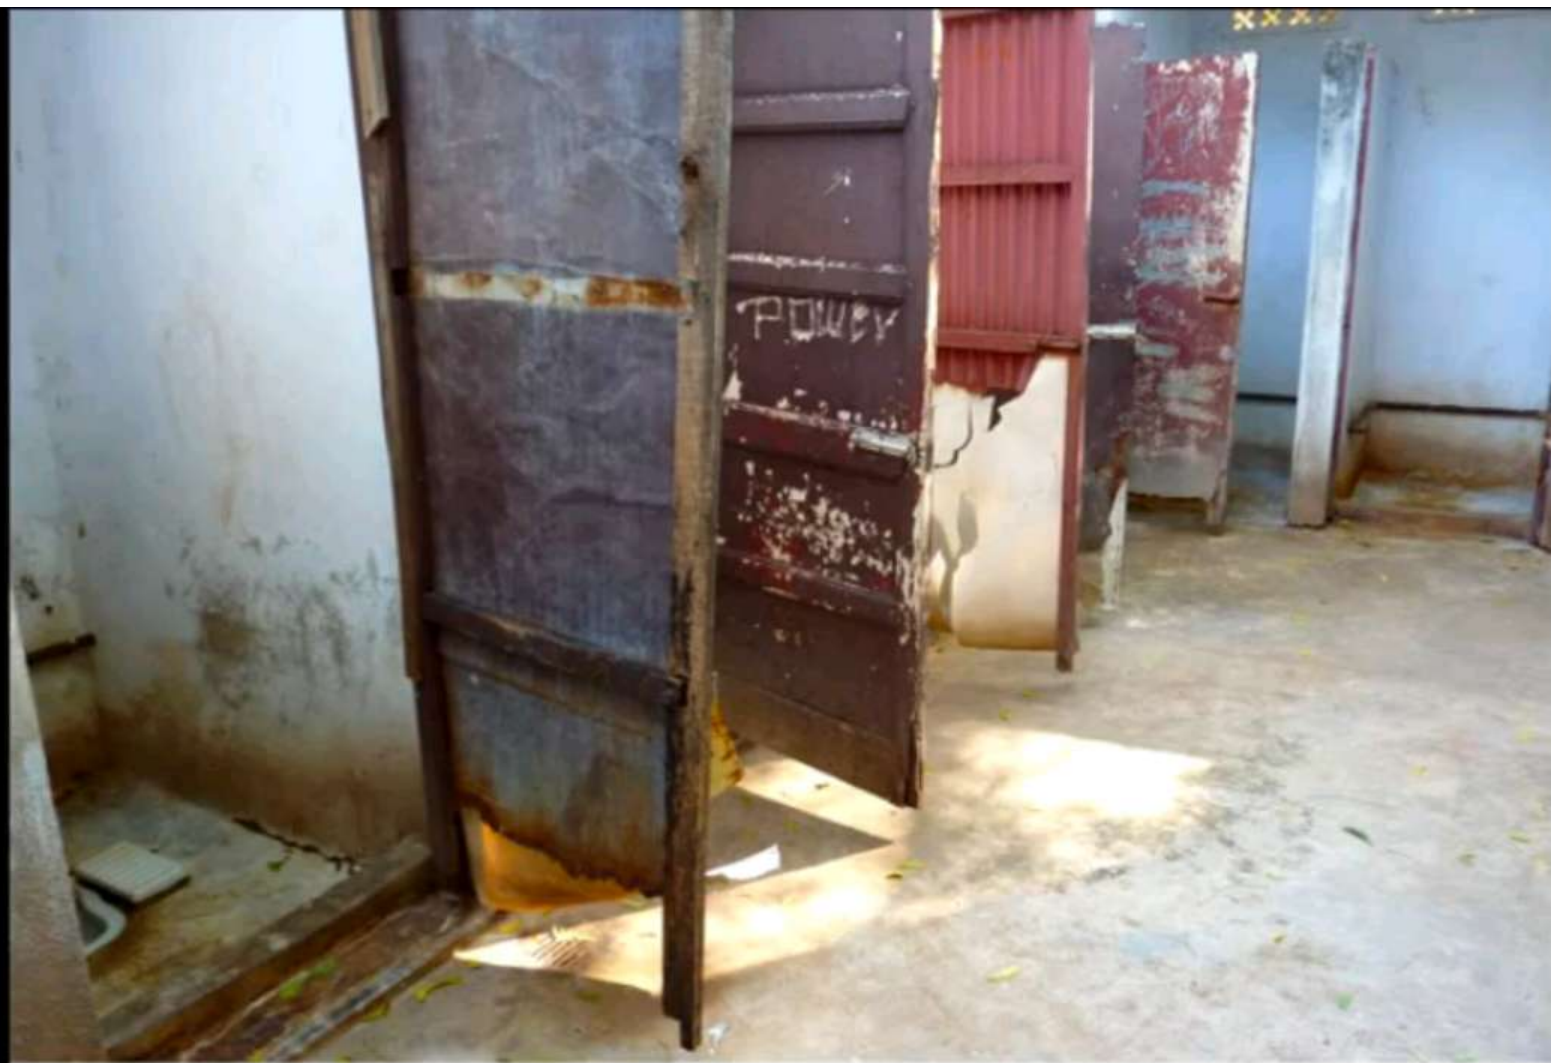
[BOYS TOILET]: Doors are barely usable. Pans are new, but note that toilets are tough to keep clean. This area being covered would be a benefit to their ability to effectively use the toilets.

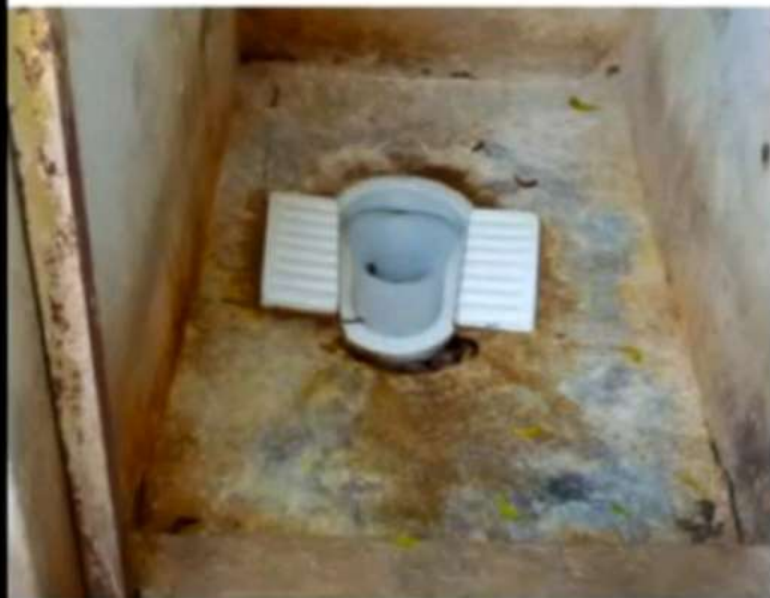
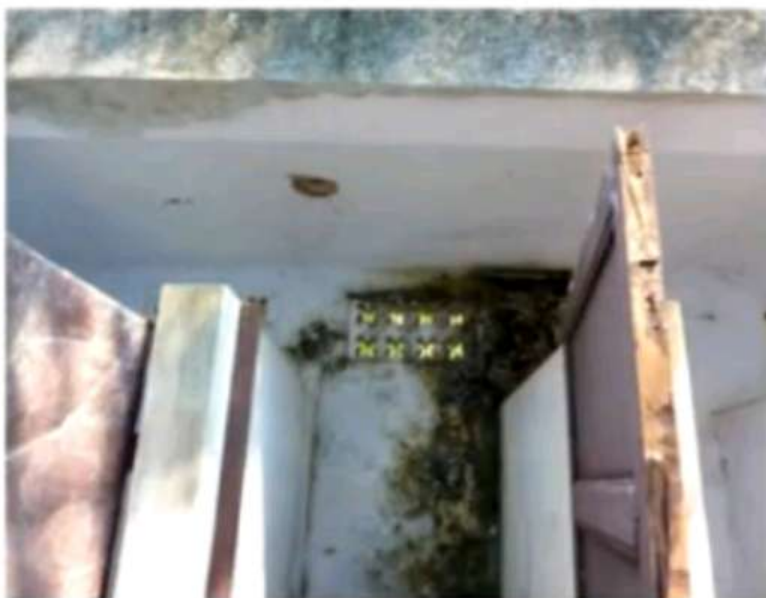
[BOYS TOILET STALLS]: Concrete is starting to crumble in places, compromising the new pans. Note the age and condition of the pipes on the following page.

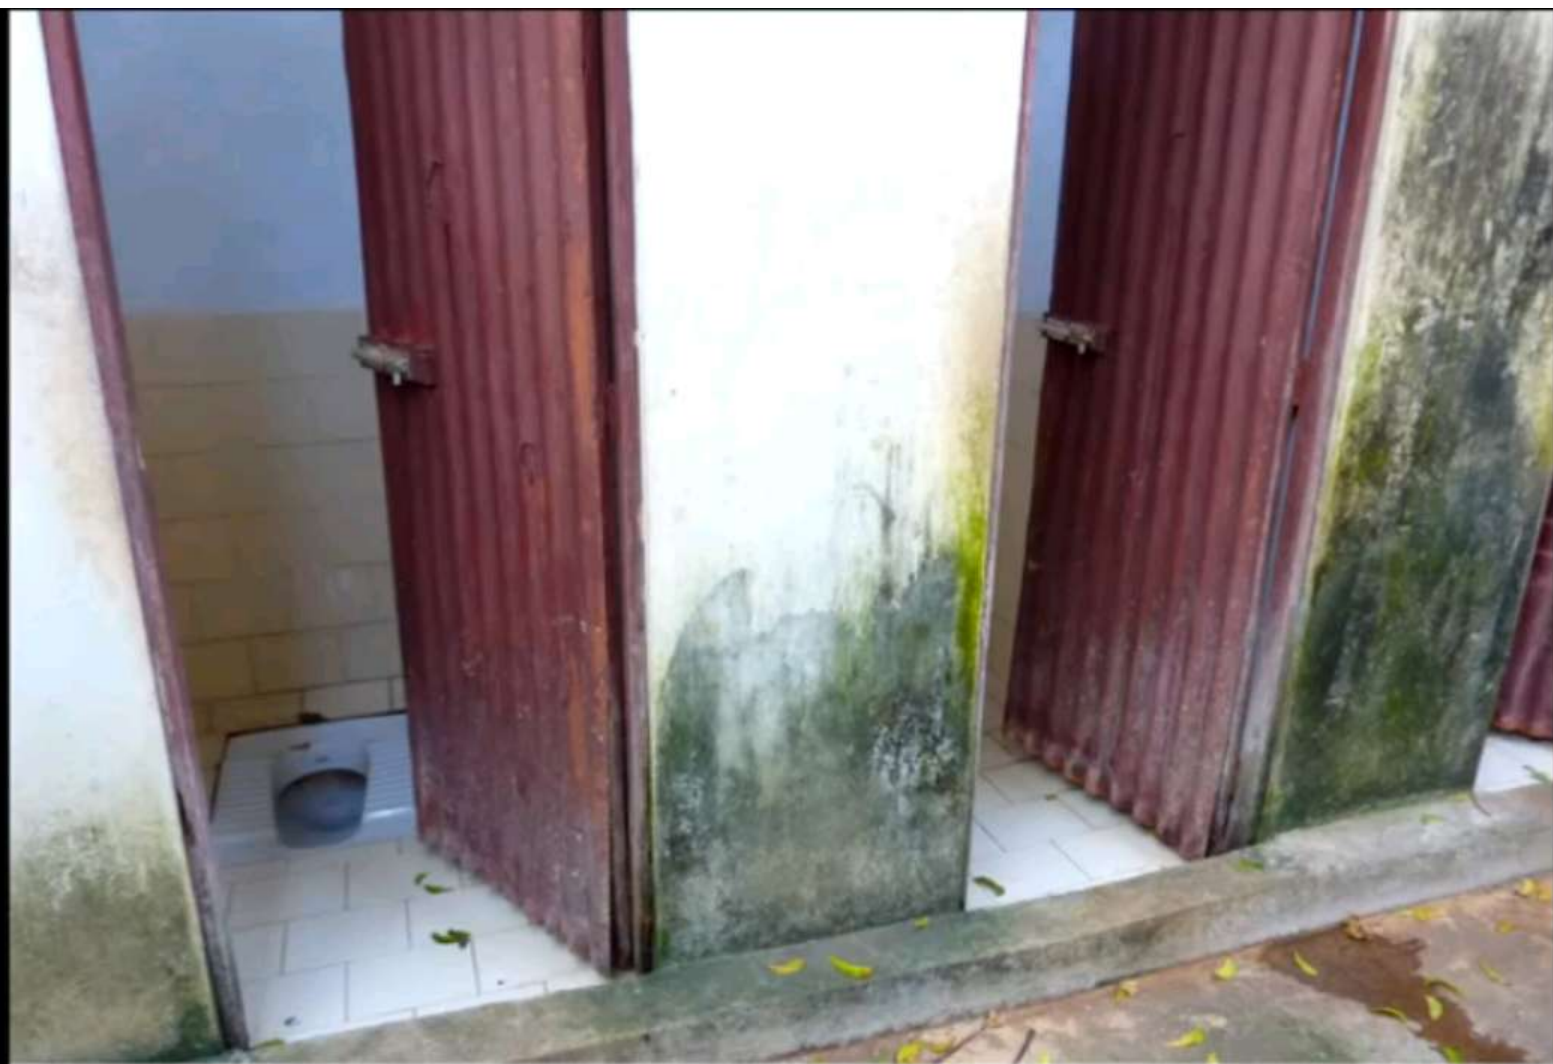
[GIRLS TOILET STALLS]: Shows renovations - new pans, AND new tiles provide great relief for ability to keep them clean. Doors are in better condition. There is no water supply into these stalls, which is still a problem.

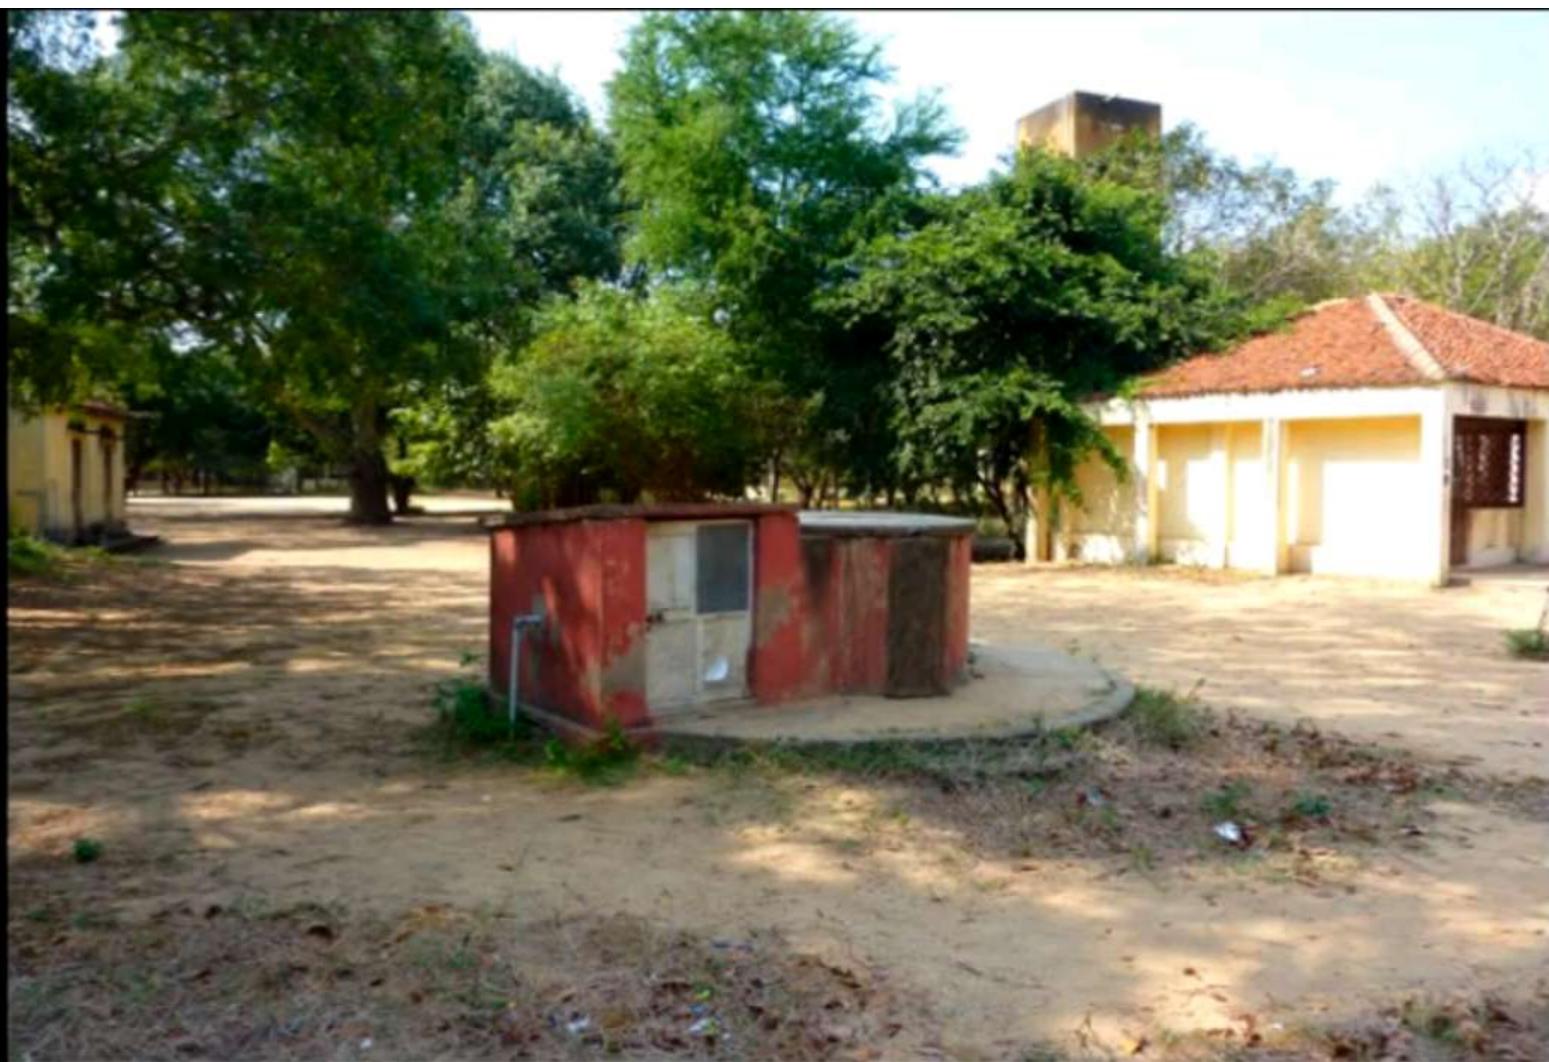
Outside the High School Toilets - Pump with Water Tower beyond.
